US ARMY CORPS
OF ENGINEERS
NEW ENGLAND DIVISION

WEST THOMPSON LAKE SERVICE BRIDGE WEST THOMPSON LAKE NORTH GROSVENORDALE, CT

August 1997

WEST THOMPSON LAKE SERVICE BRIDGE INVENTORY INSPECTION REPORT

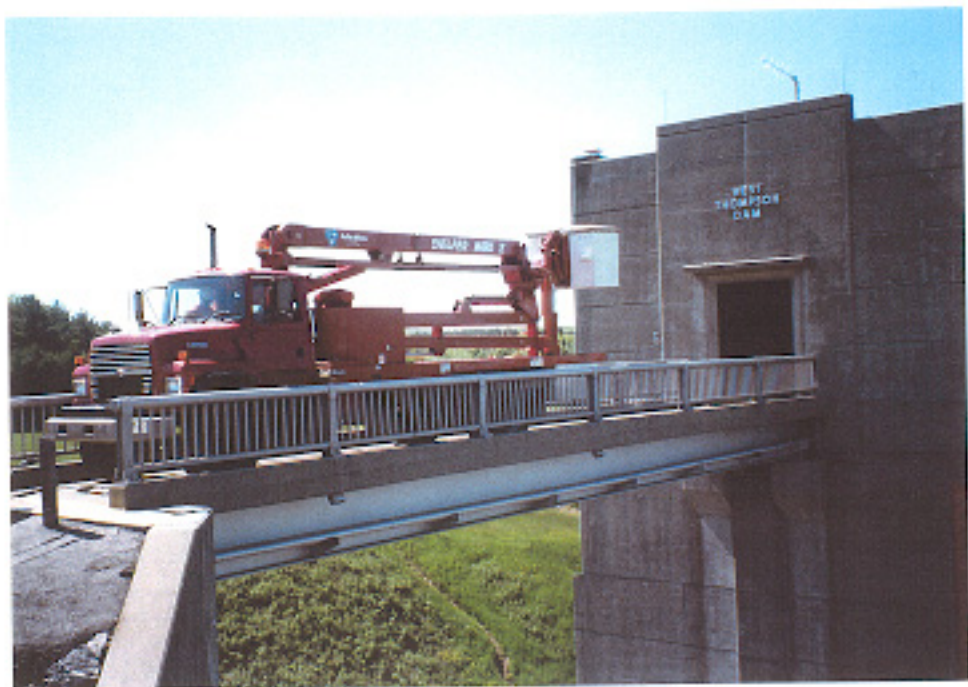
The bridge is 61'-1" long and is a single span. It is a composite structure with two plate girders supporting a reinforced concrete deck (photo 1). The bridge is oriented approximately 90°

Photo 1: West Thompson Lake Service Bridge

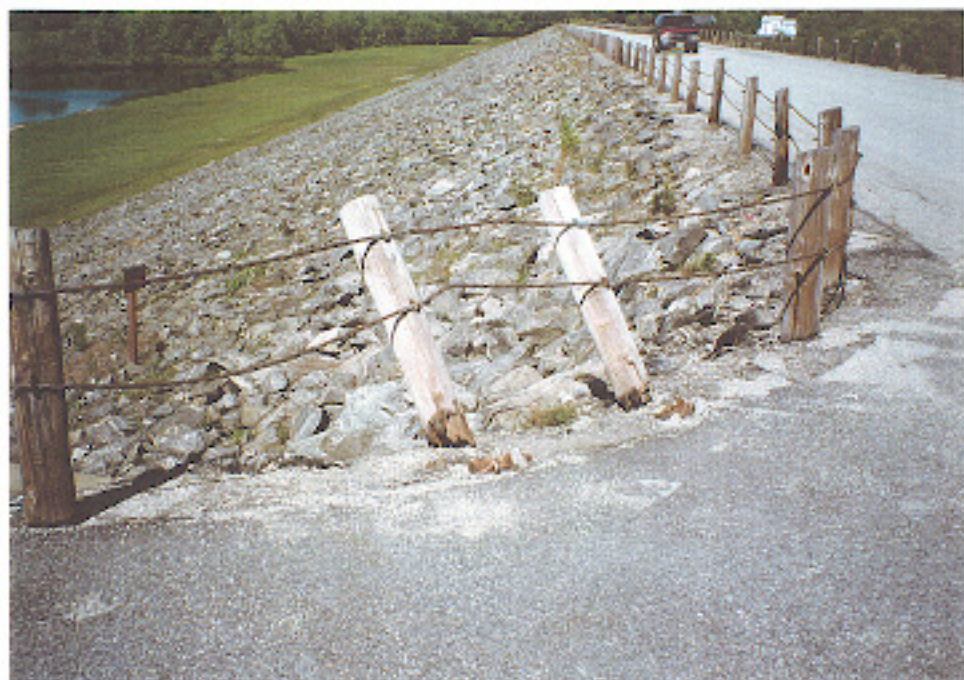
1. **APPROACH ROADWAY:** The bituminous approach roadway runs along the crest of the dam and is in good condition. There is a 90° turn from the two-lane approach road to the bridge deck. The transition from the approach pavement onto the bridge deck is smooth and in good condition. Two wooden posts supporting the dam crest cable guardrail system were struck and damaged at the southeast approach (photo 2).

5. TRAFFIC SAFETY FEATURES: The bridge is not open to the public, and only carries maintenance vehicles out to the crest of the dam. The bridge guardrail system is in very good condition. The two damaged wooden posts at the approach to the bridge pose a safety hazard.

Photo 2: Damaged Posts at the Southeast Approach

2. RECOMMENDATIONS: Replace damaged guardrail posts. Repatching delaminated concrete at the south abutment should be included in the next concrete or bridge contract at the project. Movement of bridge bearings should be checked during next 'Snooper' inspection of the West Thompson access bridge (scheduled FY 98).

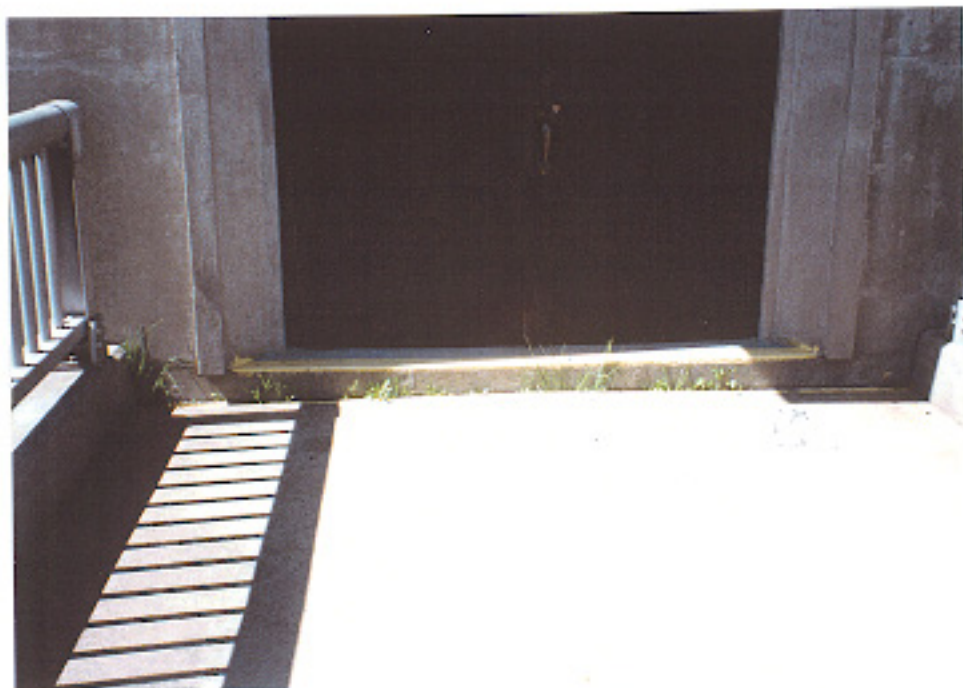
2. **DECK:** The deck is in very good condition. The concrete surface shows minor wear, and there are no cracks observed at the top surface or underside. The curbs, drains and guardrails are in very good condition. Vegetation is growing in the fixed joint adjacent to the control tower (photo 3). Utility conduits, which run the length of the deck along the exterior edges of the east and west girders, are in good condition.

Photo 3: Vegetation at the North Control Tower Deck Joint

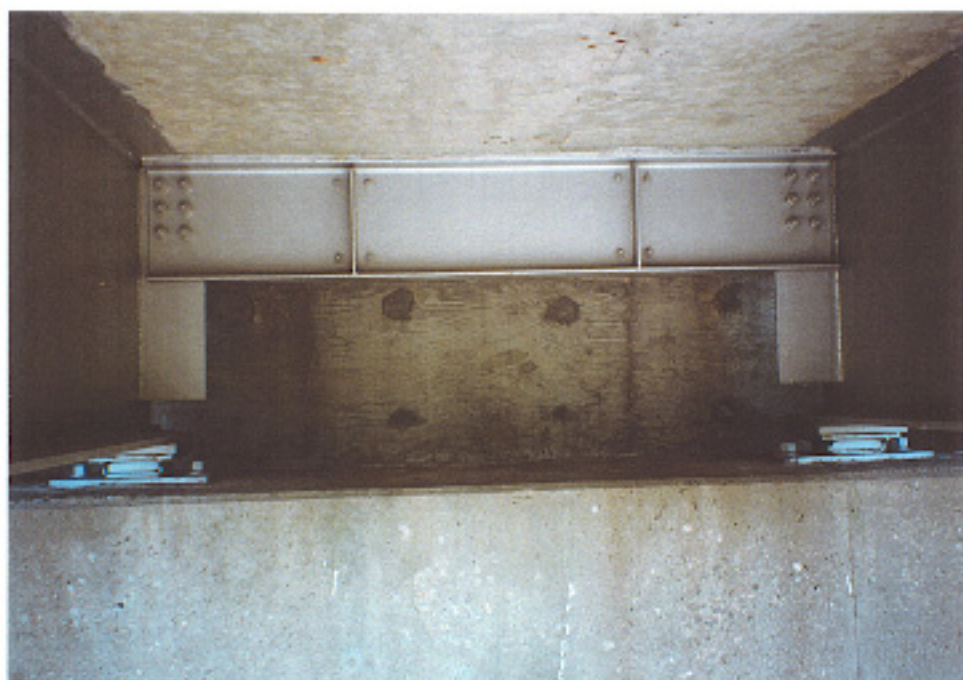
3. **SUPERSTRUCTURE:** The expansion (located at the south, abutment end) and fixed (located at the north, control tower end) bearings are in good condition with minor corrosion (photos 4 and 5). Bolts at the expansion bearings are observed to be bent slightly towards the backwall of the abutment. The gap between the bottom of the bolt and the top of the bearing plate is as follows:

Photo 4: Expansion Bearings at the South Abutment

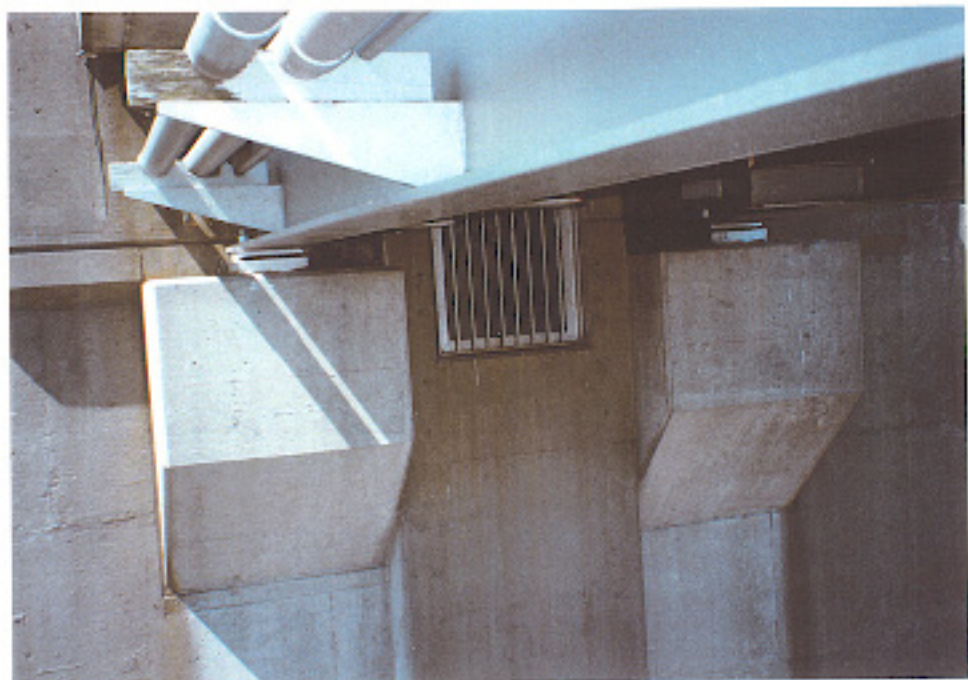
Photo 5: Fixed Bearings at the Control Tower Haunches

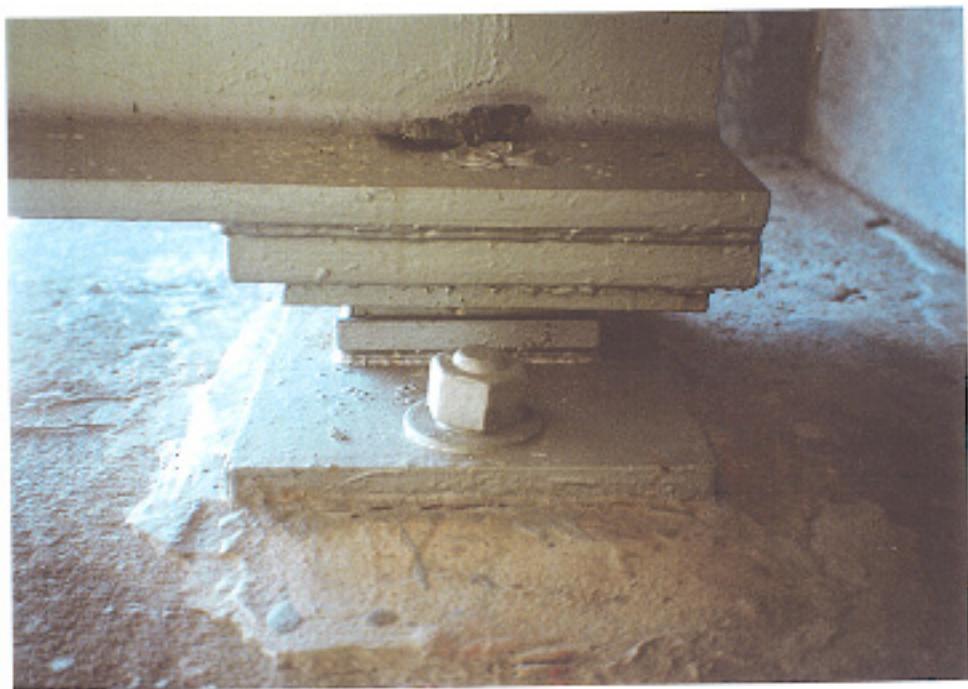
East Girder - interior bolt	3/16"	(photo 6)
- exterior bolt	ok	
West Girder - interior bolt	1/4"	(photo 7)
- exterior bolt	3/16"

Original expansion bearings were replaced in 1985 with new sliding bearings. These new bearings may not be sliding. Bolts at the fixed bearings are also bent towards the backwall of the concrete haunch. The gap between the bottom of the bolt and the top of the bearing plate is as follows:

Photo 6: Bent Interior Bolt at the Southeast Girder End

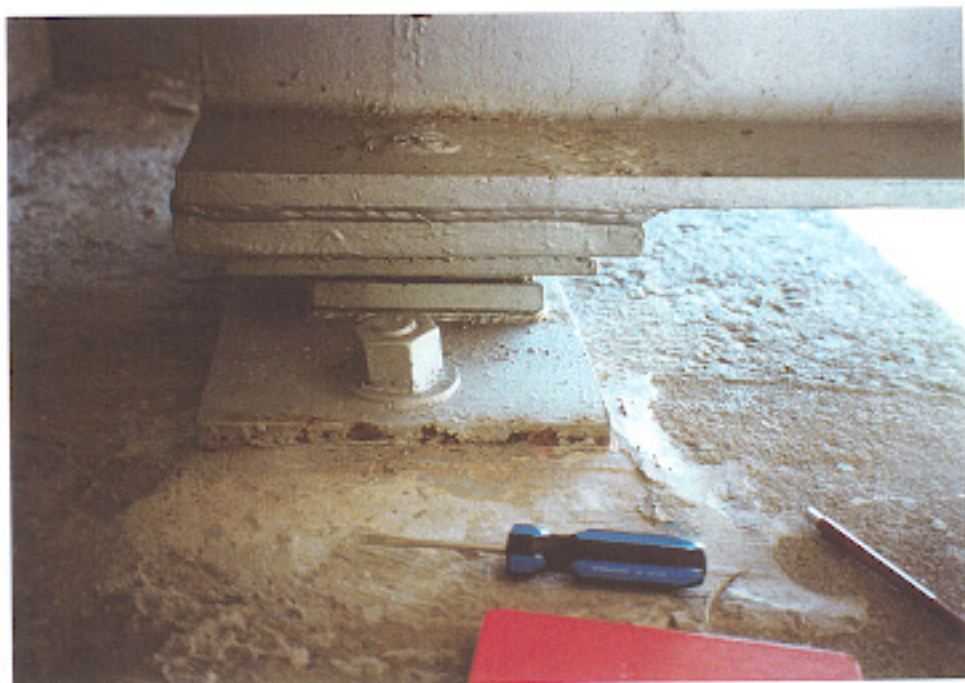
Photo 7: Bent Interior Bolt at the Southwest Girder End

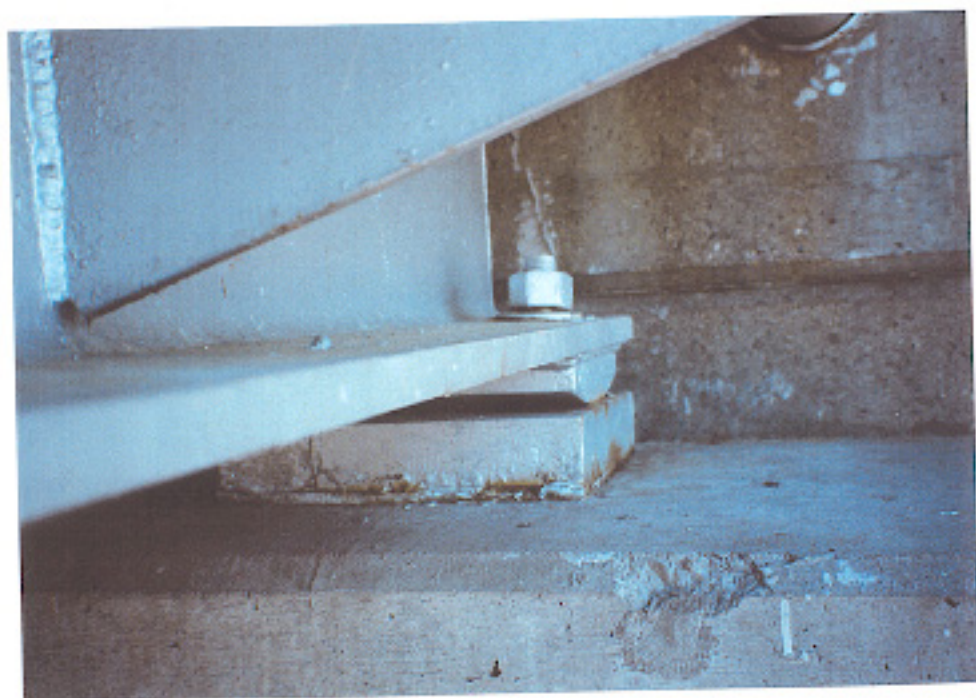
East Girder - interior bolt	ok
- exterior bolt	7/16" (photo 8)
West Girder - interior bolt	1/16"
- exterior bolt	3/16"

Photo 8: Bent Exterior Bolt at the Northeast Girder End

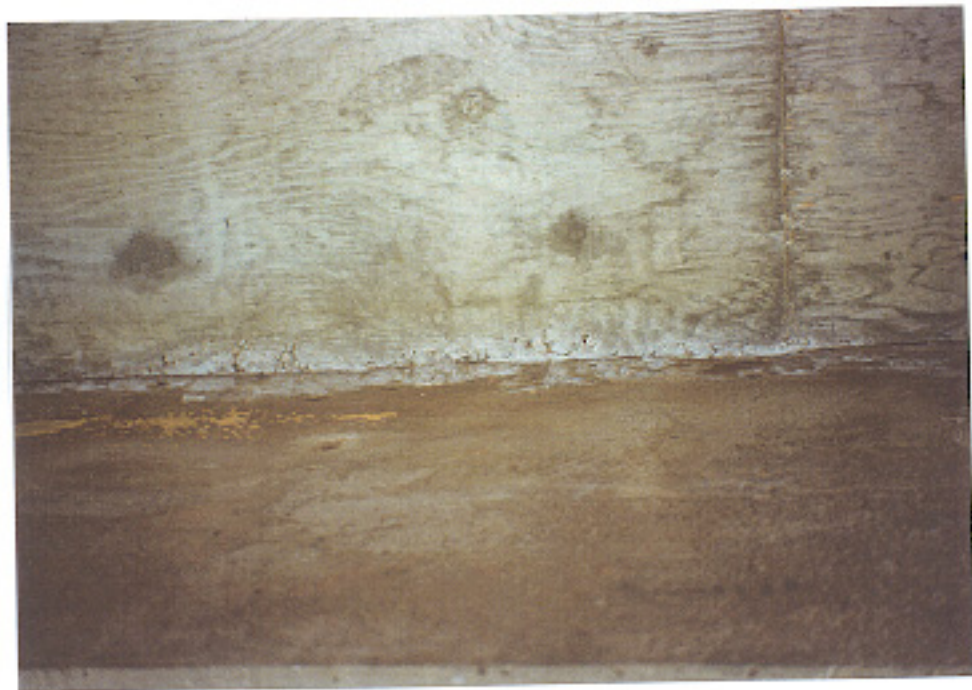
4. SUBSTRUCTURE: The southern abutment is in good condition with minor honeycombed concrete noted at the intersection of the backwall and the bridge seat (photo 9). The concrete at the east and west corners of the abutment, where the wingwalls meet the breastwalls, was previously patched (photo 10). The west corner is in general good condition. A 4 foot by 4 foot triangular area at the east corner patch is delaminating with some efflorescence evident at the lower edge of the patch (photo 11). At the east concrete control tower haunch, which supports the steel girder, there is a 6" by 3" area of spalled concrete at the sloping lower side of the haunch. The rebar is exposed (photo 12). It appears that the rebar was originally placed with inadequate cover. Both haunches have accumulated minor amounts of debris.

Photo 9: Honeycomb at the South Abutment Backwall

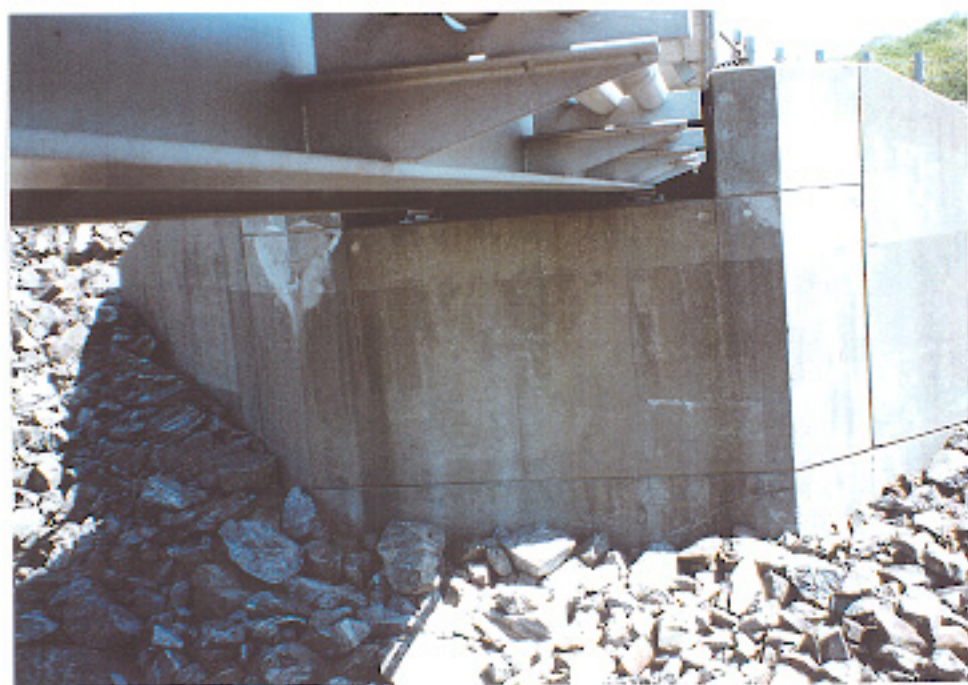
Photo 10: Concrete Patches at the South Abutment

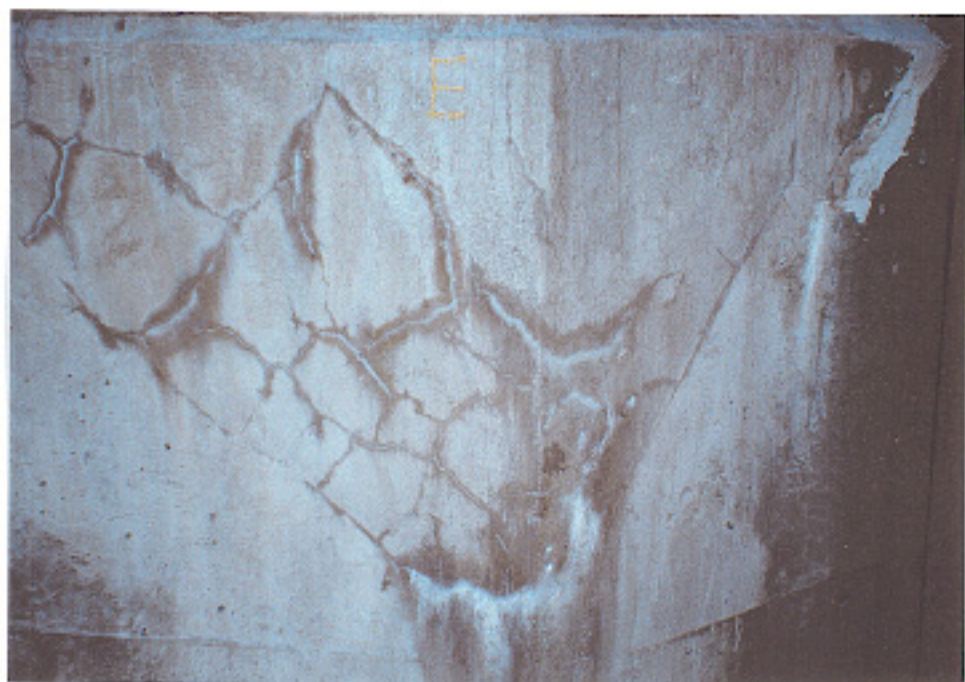
Photo 11: Delamination and Efflorescence at the Southeast Wingwall

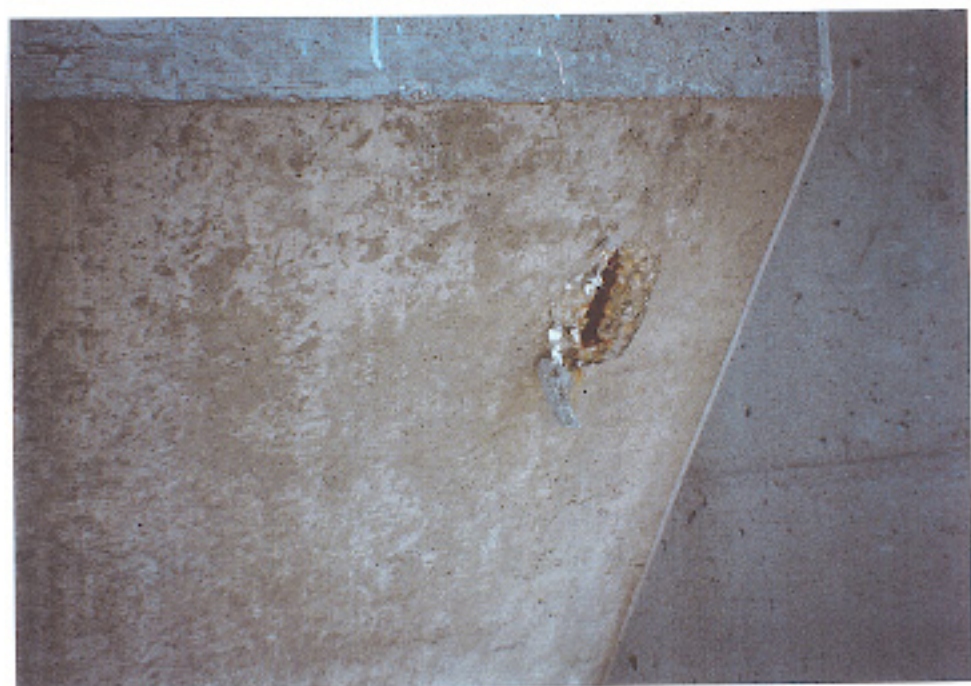
Photo 12: Spall at the Northeast Control Tower Haunch
